Zion-Mount Carmel Highway  
Zion National Park  
Springdale vicinity  
Washington County  
Utah

HAER No. UT-39

Zion-Mount Carmel Highway

Significance: This approximately 10-mile park section of a 25-mile road is of great scenic interest and retains structural integrity. The conception, design and construction of this road was an artistic achievement.

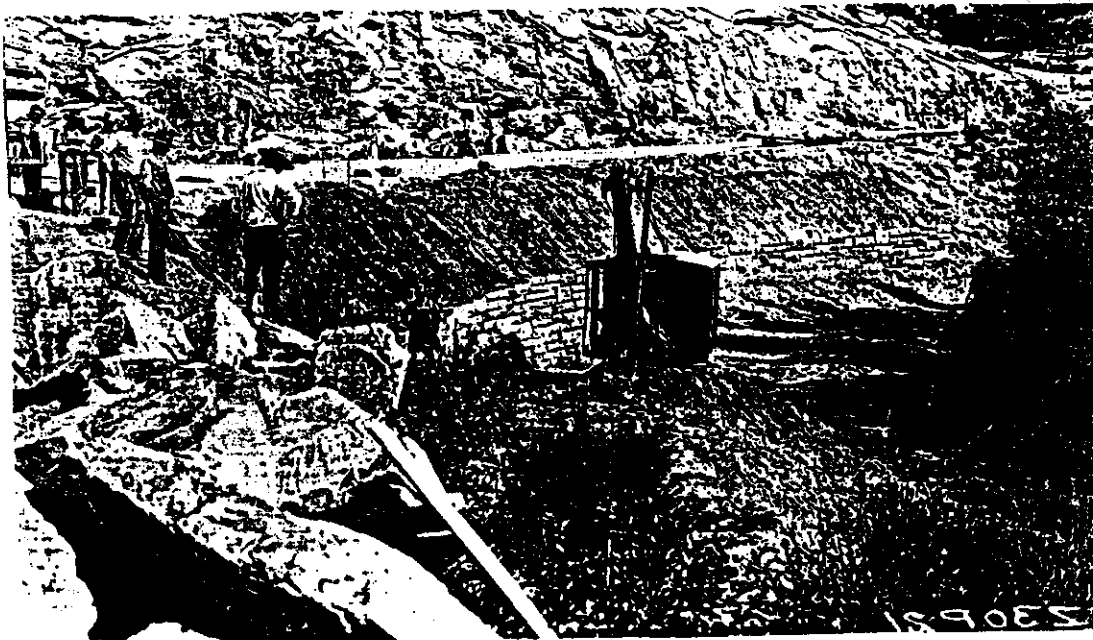
Backfilling retaining wall construction with a Park power shovel -- east of tunnel. (Zion NP archives)

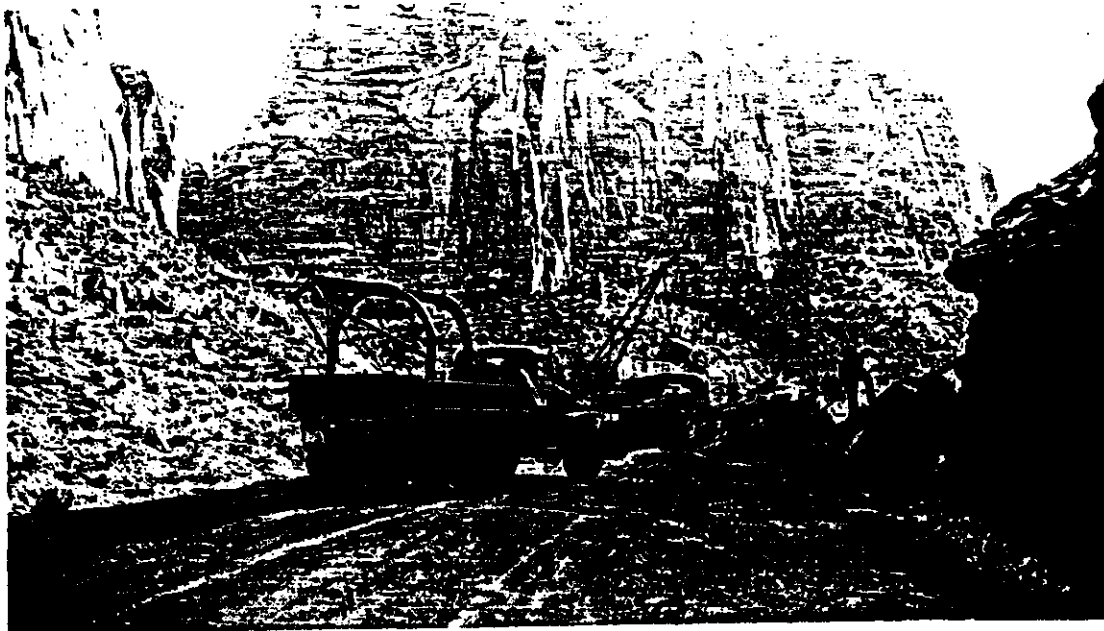
Clearing a slide at the Nevada Switchback -- 1950.  
(Zion NP archives)

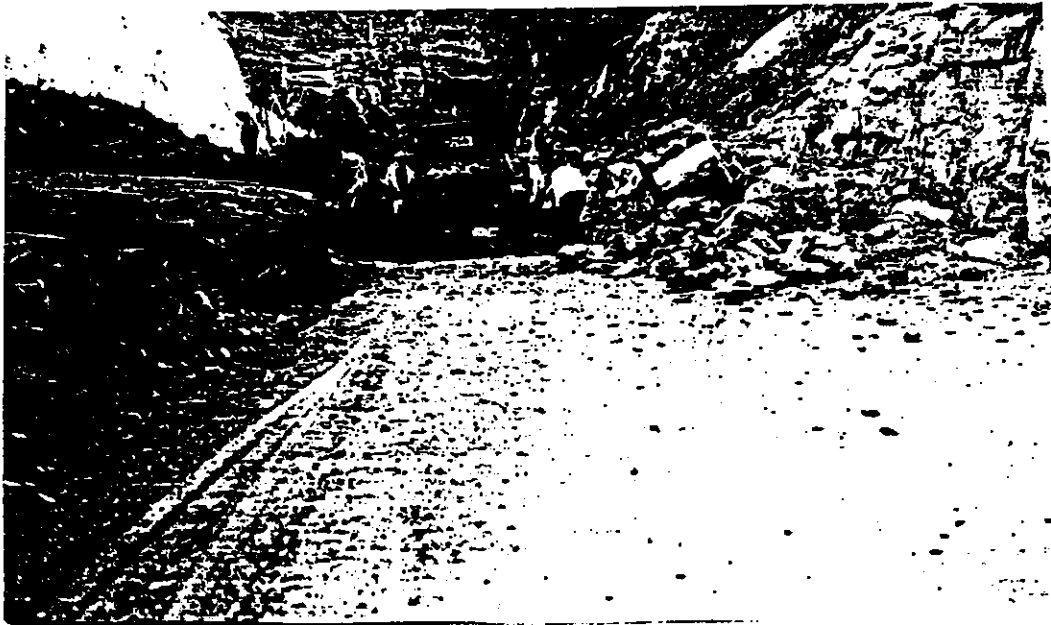
Removing slide debris on the switchbacks -- 1932.  
(Zion NP archives)
